The Future of the Champlain Bridge

Prepared for:
**The Jacques Cartier and
Champlain Bridges Incorporated**

March 22, 2011

Delcan was retained in August 2010 by The Jacques Cartier and Champlain Bridges Incorporated to carry out a Structural Health Assessment Study of the Champlain Bridge.

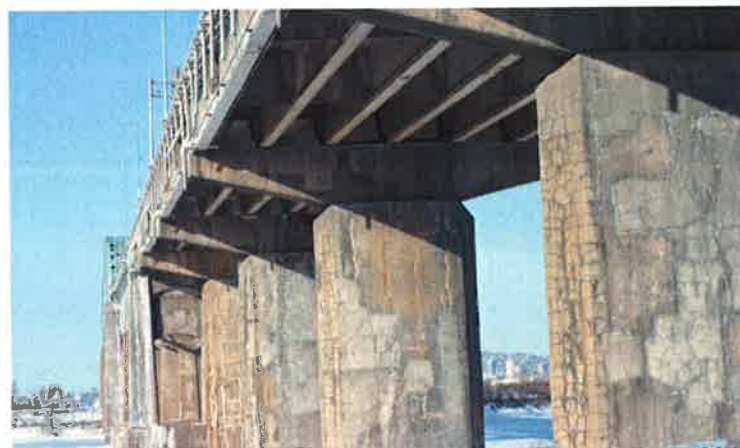
Figure 2 - Prestressed Concrete Girders and Reinforced Concrete Piers

At the same time, many elements of the bridge are in a condition which may be described as 'poor' to 'deficient'. These include such elements as (possibly) the underwater portions

of the foundations, the pier stems, the non-repaired pier caps and crossbeams, the prestressed concrete edge girders in Sections 5 and 7, the ends of the prestressed concrete girders in Sections 5 to 7, the expansion joints, the non-repaired bearings in Sections 5 and 7, and ancillary elements. As well, there are localized defects in such elements as the transversely post-tensioned concrete deck in Sections 5 and 7, and some evidence of deterioration of some of the transversely post-tensioned concrete diaphragms in Sections 5 and 7.

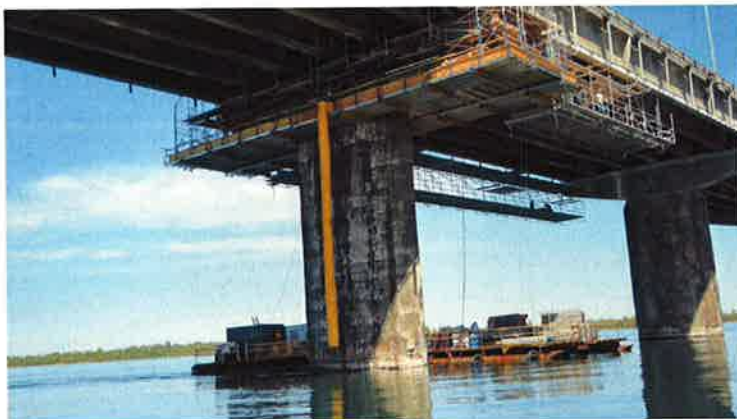
Figure 3 - Repairs to Reinforced Concrete Pier Cap Beams

In addition, there is some concern with regard to alkali aggregate reaction in this concrete. These two factors mean that short of the entire replacement of the piers, including the pier stems and the pier caps as well as the pier crossbeams in the main spans, some deficient or

degraded concrete will remain as a part of the rehabilitated structure. This is considered to be compatible with a relatively short-term service life in the order of 10 years but not with long-term service lives in the order of 50 years or more.

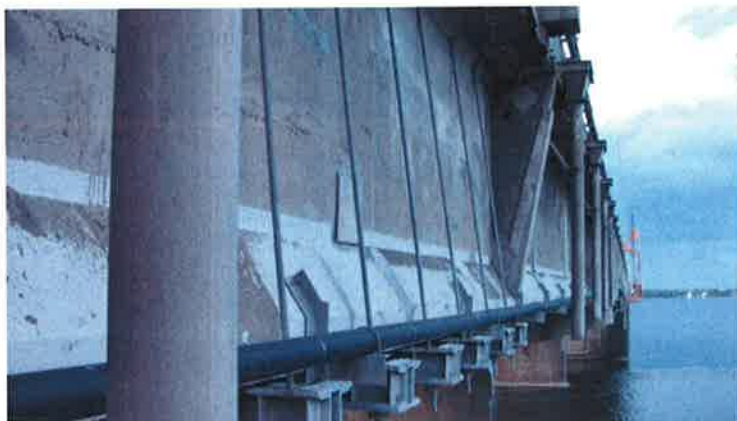
**Figure 4 - Repairs to Prestressed Concrete Girders
including External Posttensioning**

While there are a number of significant deficiencies in the bridge, the most significant and complex to manage is the deterioration of the edge girders in the prestressed concrete

grillage spans which form the approach spans in Sections 5 and 7. A series of steps has been taken over many years with a view to inspecting, analyzing, understanding and dealing with the deterioration which these girders have experienced. Steps which have been taken include improving the drainage system on the bridge so that salt-laden water is not directed from the bridge deck onto the surfaces of the girders, the application of coatings with a view to protecting the girders from salt-laden water, the addition of external post-tensioning including horizontal post-tensioning to deal with deficiencies in bending moment and inclined post-tensioning to help deal with deficiencies in shear capacity, concrete repairs including the replacement by patching of concrete lost from the girder webs, local addition of external stirrups, and replacement of the bearings which support these girders and the entire superstructure on Sections 5 and 7.

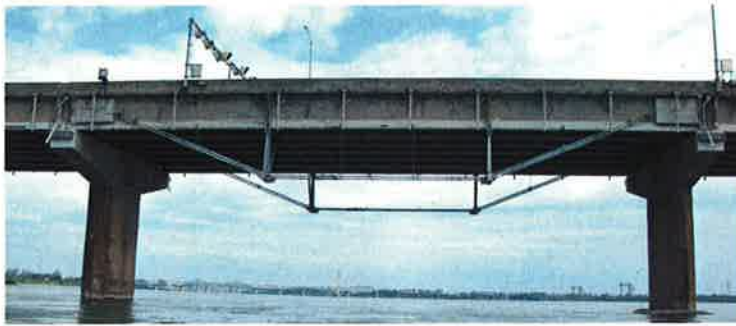
**Figure 5 - Repairs to Prestressed Concrete Girders
Including Queen Posts and External Post-Tensioning**

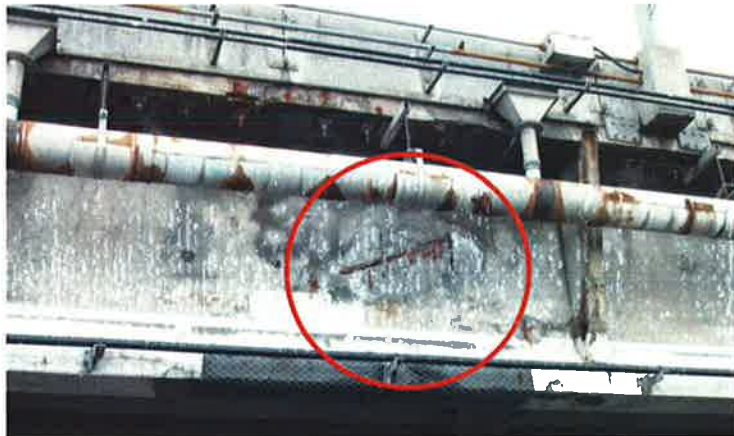
Some of the exterior girders are so significantly deteriorated that one can see the ducts which contain the high-strength steel tendons, as a result of cracking in the exterior girder webs located at the ducts. This is something which is unique in our experience. It is believed that the grouting which was used in these ducts originally may have frozen and there is considerable concern with regard to the quality of the grout that was used in the ducts. This is an issue that should not be forgotten in assessing the interior girders as well. This kind of deterioration combined with the other more generalized deterioration, the loss of the high-strength tendons in some of the girders, and the corrosion and concrete deterioration which is evident, suggest that some of these girders are beyond repair in the context of a long service life, particularly in the context of concrete which is not air entrained in accordance with current standards for durability. The repairs which are being applied to these girders including external post-tensioning to provide additional bending and shear resistance, are compatible with reducing risk but the degree of reduction of risk must remain unknown as, despite detailed efforts to assess the condition of the cables and the

condition of the precompression remaining in the girders, some doubt must remain as to the actual condition of the girders even after all of the requisite repairs are carried out and the external post-tensioning is applied. For this reason, it is appropriate to consider Structural Health Monitoring, as has been done to some extent here but, at the same time, it is possible that even with Structural Health Monitoring, given the condition of these girders, the first signal from the Structural Health Monitoring system as to difficulties on the bridge may not occur until the difficulties are severe enough to cause safety issues to arise on the bridge.

**Figure 6 - Web of Prestressed Concrete Girder
with Tendon Partially Visible**

This, we believe, is the case as well at the Champlain Bridge in the case of Section 5 and Section 7. In the context of an extension of the bridge service life to 50 years or more, it is likely that the entire superstructure for Sections 5 and 7 would have to be replaced.
